## Restores Stainless steel Lanai railing in Hawaii

Six months after installation, unsightly rust stained 316 Stainless steel support posts on railing ruins pristine appearance of \$25,000.00 installation at a Hawaiian estate.

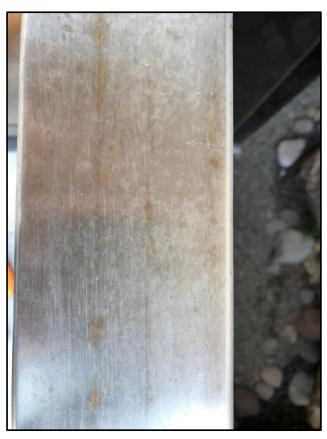
Close-up photos of support posts show unsightly pitting and staining.

High strength 316 grade Stainless steel is susceptible to rusting.

Warm, damp environments accelerate the damage.

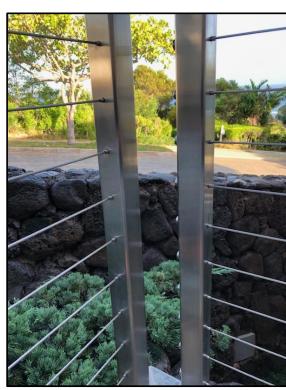
The guard rail shown at right will maintain the "like new" appearance as the Fortify sealed post for many years once cleaned and sealed.
